Fluviokarst in the top of the Maastrichtian chalk at Rørdal, Northern Jutland, Denmark

ERIK STENESTAD

Key words: Fluviokarst, sinkhole, doline, buried valley, crop mark, pre-Pleistocene surface, ground water pollution, Maastrichtian chalk.

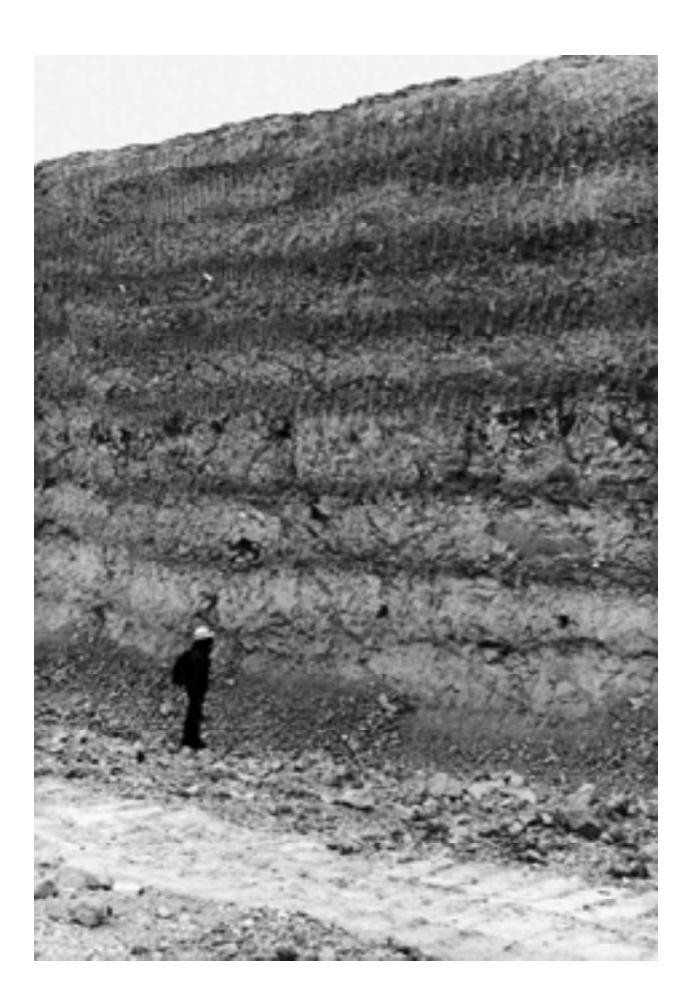
Fig. 1. Rhythmic sedimentation of upper Maastrichtian chalk at Rørdal.

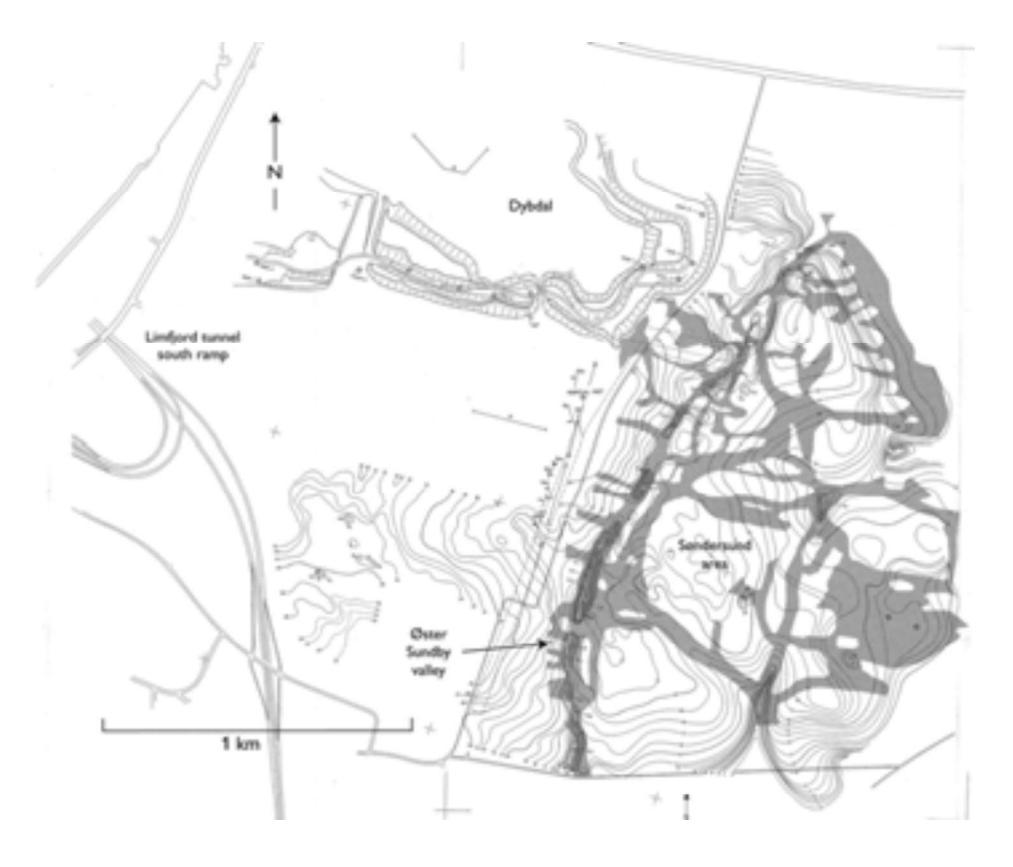
Fig. 3. Rørdal quarry, Dybdal and the Søndersund area. The crop marks from figure 4 are shaded on the contour map of the pre-Pleistocene surface. The equidistance of contours is 1 m. The boreholes in Dybdal are shown without the DGU file numbers used in figure 17.

The valley is narrow and deep and the bottom topography is very uneven as indicated by the boreholes in the valley (Figs 3, 17). Geoelectric measurements in the valley failed because of interference from the narrow walls of chalk. However, one of the boreholes in the valley centre (Geological Survey of Denmark File no. 26.2213) did not reach the chalk at the final depth at level -38 m some 50 m below the surface of the chalk adjacent to the valley.

A number of shallow boreholes and excavations were made in order to map the surface of the chalk. The resulting contour map of the pre-Pleistocene surface demonstrates that the crop marks are clearly related to the relief of the top of the chalk (Fig. 3). The Øster Sundby valley follows the orientation of

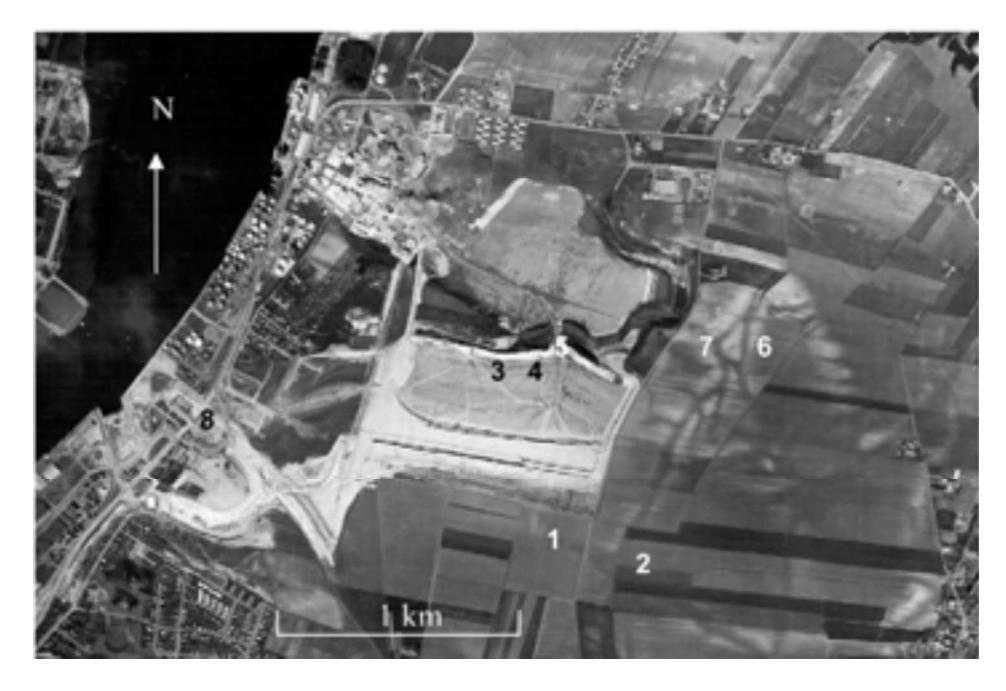
Fig. 4. Aerial photograph of the Rørdal area showing the same area as figure 2. Note crop marks. Localities nos. 1–8 are indicated. Based on an excerpt of Danish Geodetic Institute aerial photograph route 349 nr. 245. (Reproduced according to authorization A.63/75).

The description is based on observations in quarry profiles, excavations and cores from boreholes. A dense grid of drill holes was used to establish the relief of the pre-Pleistocene surface in the Søndersund area (Figs 2,3). Aerial photographs showing crop patterns helped to track the buried Øster Sundby valley (Fig. 4).

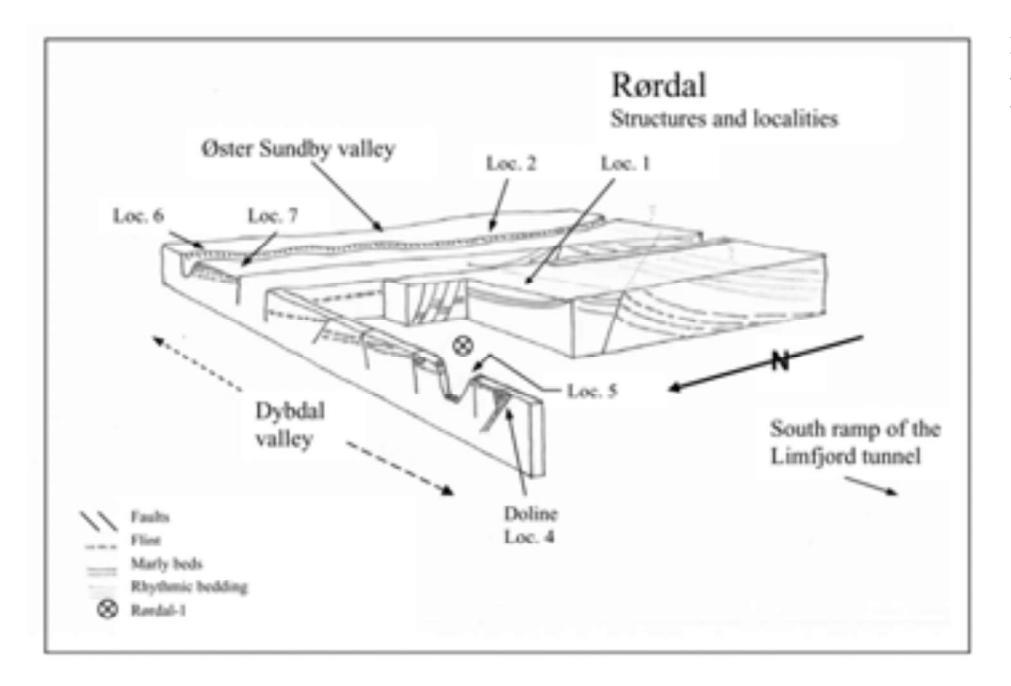
Fig. 5. Rørdal quarry. Structures and localities. The represented area is c. 1×1 km. (Cfr. Fig. 2).

The chalk that is exposed in the sections is white to greyish white with 90–95% carbonate and less than 0.5% Fe₂O₃ and MnO, while the remaining impurities mainly comprise clay, and a few angular silt-size quartz grains. Flint nodules are generally scarce and are found only at a few levels (Fig. 5). The chalk is thoroughly bioturbated.

Marly beds and rhythmic bedding is found only in the southern part of the area (Fig. 5). This area is also characterised by many flint nodule beds. Minor faults were found in all parts of the chalk in the Rørdal quarry. Joints striking N–S, E–W, NE–SW and NW– SE are widespread in the chalk, and these directions coincide with the direction of the valleys eroded in the chalk (Fig. 6).

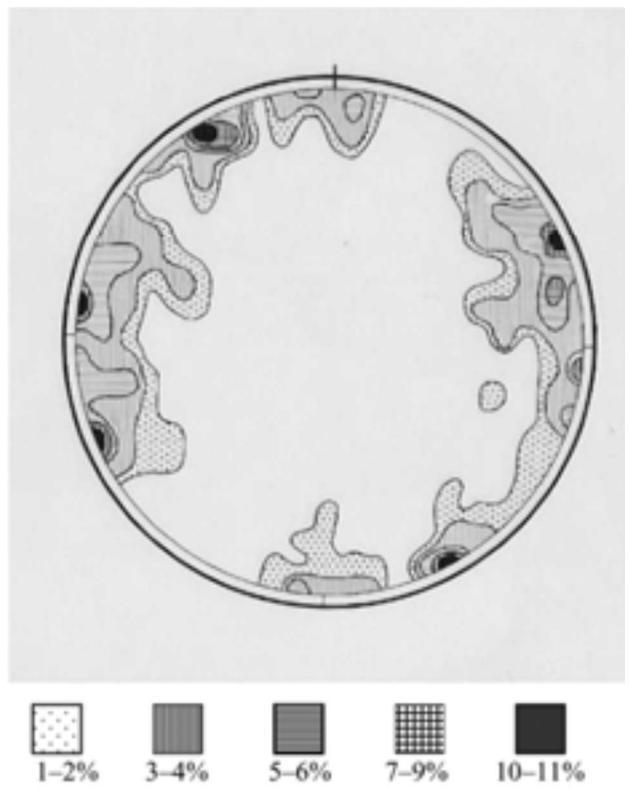
Fig. 6. Joints diagram based on 80 measurements. Lambert equal-area projection on lower hemisphere.

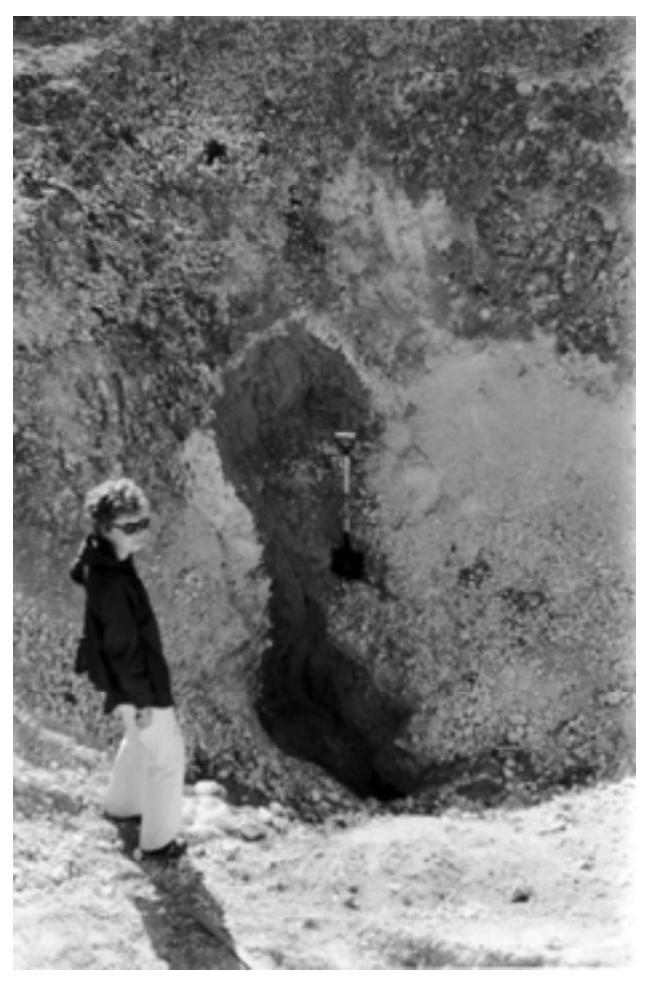
Fig. 7. Locality 1. The partly excavated doline viewed from top of the chalk. The dark section next to the spade represents layers (2) to (6) in fig. 8. The bottom layer (7) is not visible.

A major circular, funnel shaped hollow in the surface of the chalk was studied in the southern part of the quarry (locality 1, Figs 2, 4, 5). The overburden and most of the pebbly sand in the upper part of the hollow had been removed (Fig. 7). The top diameter of the excavation was c. 5 m and the depth c. 6 m (Fig. 8). The hollow is filled with greyish-brown or ochre-coloured sandy deposits, including fine to medium-grained coarse sand with pebbles and up to 15 cm large blocks of white chalk alternating with clayey and silty layers. Spots of soil rich in organic matter, crumbling pebbles and ochre-covered flint nodules in undisturbed sand layers near the bottom of the hollow indicated the former presence of a connection to a weathered land surface. In the bottom of the hollow two undisturbed planar flint nodule beds and soft, wet, white chalk indicated *in situ* dissolution of the chalk.

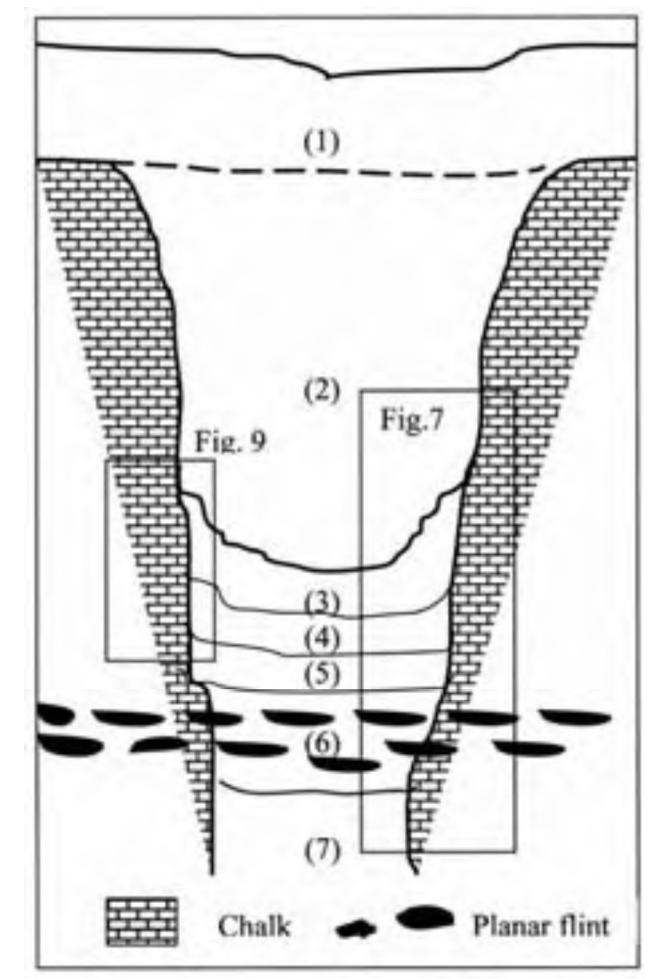
Fig. 8. Locality no.1. Doline. Diagram not to scale. Top diameter of the hollow is c. 5 m and the depth is c. 6 m. (1) Overburden; (2) Pebbly sand (partly removed), fine, greyish brown; (3) Sand, fine to medium-grained with pebbles, light greyish brown or ochre-coloured, with up to 15 cm large blocks of white chalk; (4) Sand, fine to medium-grained, greyish brown, with few pebbles, alternating with clayey and silty layers; (5) Sand, fine to medium-grained, greyish brown, with spots of soil rich in organic matter, with crumbling pebbles and ochre-covered flint nodules; (6) Sand as (5) with two undisturbed horizontal planar flint beds; (7) Chalk, white, soft, wet.

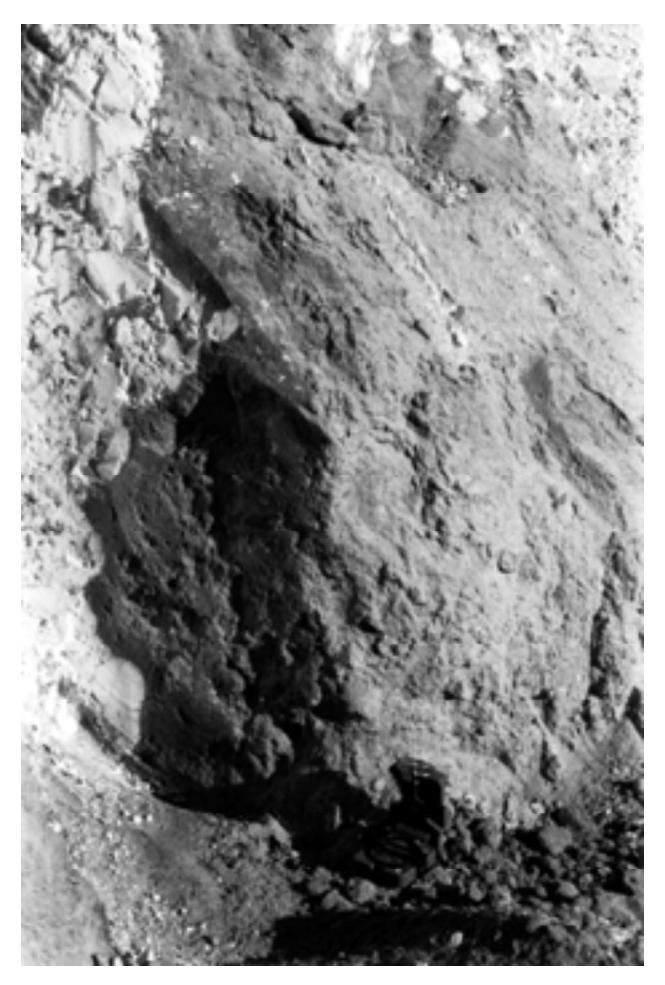
Fig. 9. Locality 1. Close up of contact to chalk *in situ*. (Cfr. Fig. 8)

The smooth and corroded walls of the hollow in the soft crumbling chalk also indicated dissolution of the chalk (Fig. 9). The contact sediment of clayey and silty sand may have been formed as layers of silt and clay on the surface of the chalk gradually

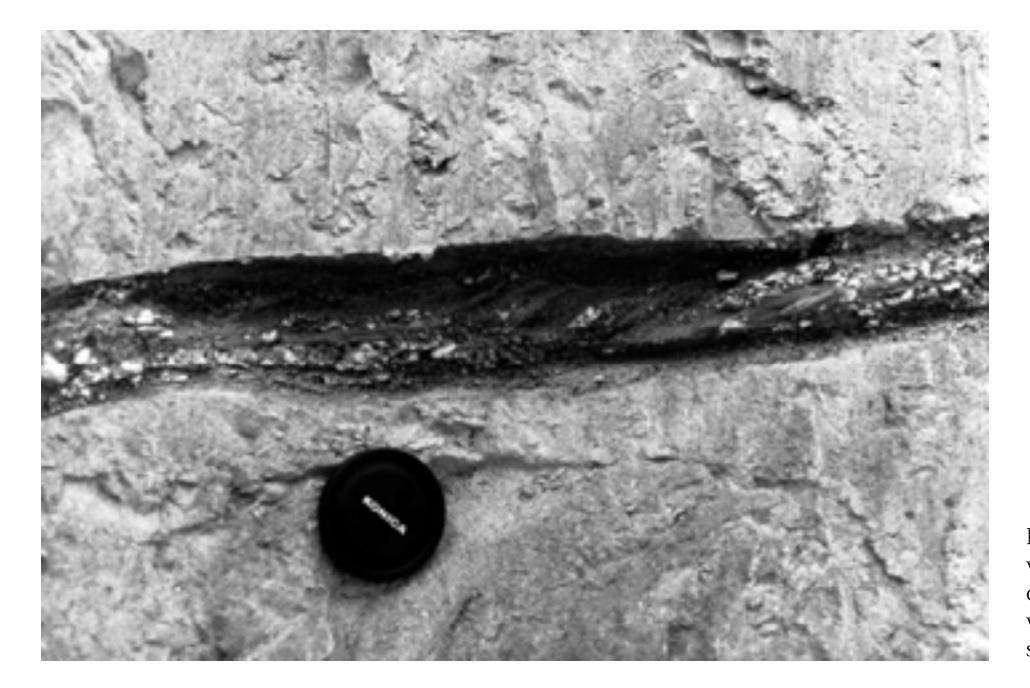
Fig. 10. Close-up of quarried wall near locality 1. Open channel in the chalk infilled with cross-stratified fluvial sediment.

Vertical and extensive horizontal subsurface channels in the chalk were exposed in the walls of the quarry quite near locality 1. The horizontal originally open subsurface channels are 5–10 cm deep and are infilled with cross-bedded sand and gravel by eastbound streams as is indicated by the east dipping foresets (Fig. 10). The subsurface channels are interpreted as fluviokarst channels developed by running water in combination with dissolution processes.

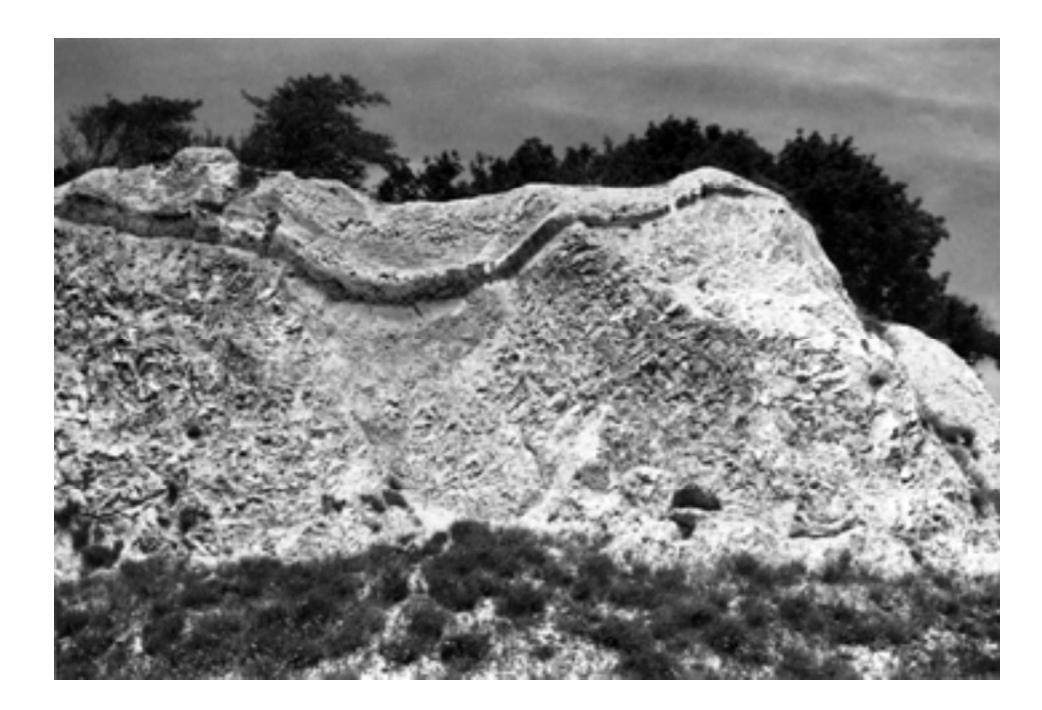
Fig. 11. Locality 4. General view of the doline next to Dybdal.

A funnel-shaped structure and an irregular horizontal channel with a sand-filled cavity was noted in the chalk in the quarry wall next to the Dybdal valley (locality 4, Figs 2, 4, 5). The funnel was c. 6–7 m in diameter and c. 4–5 m deep (Figs 11,12). Parallel faults ($170^{\circ}/68^{\circ}$ E) formed the shaft and one side of the funnel. Fine-grained partly stratified sand and cobbles with a diameter of 15–20 cm were deposited

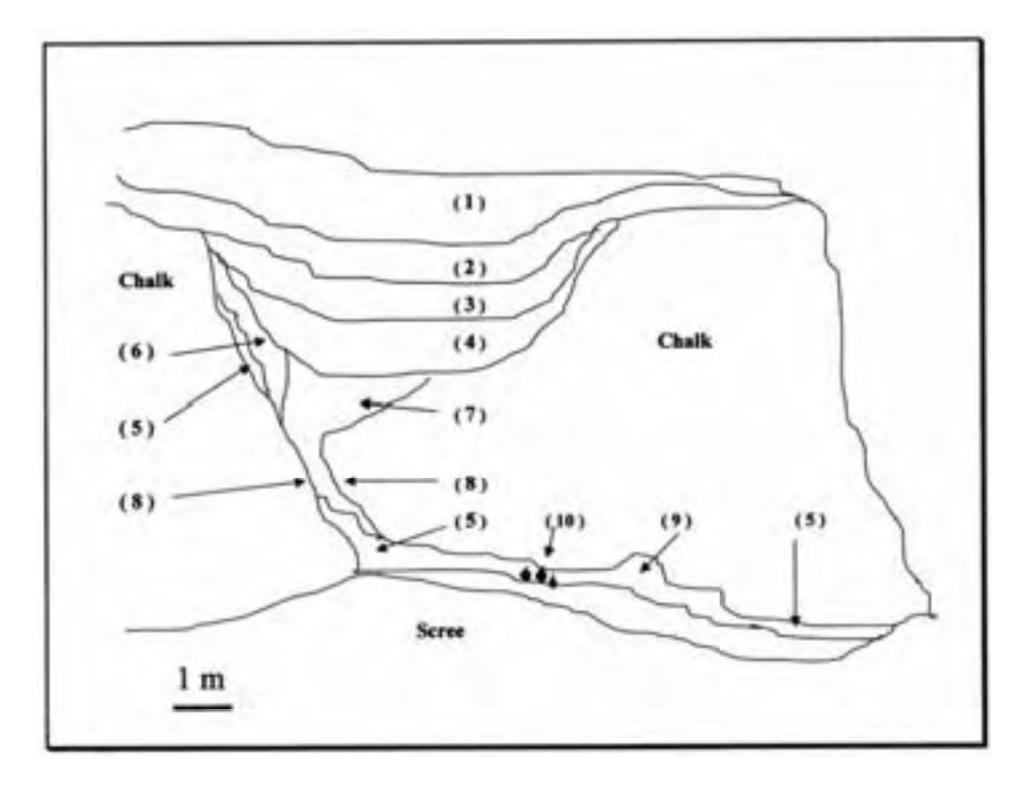
Fig. 12. Locality 4. Explanatory sketch to figure 11. (1) Landfill; (2) Soil; (3) Silty fine sand; (4) Stratified fine sand; (5) Sand, fine, partly stratified; (6) Block of solid chalk; (7) Fallen chalk fragments; (8) Faults; (9) Sand-filled cavity; (10) Cobbles with a diameter of 15–20 cm.

Locality 4 is interpreted as a doline formed in connection with a subsurface channel that drained away percolating water. Most likely a sinkhole was first developed in a water-eroded system of parallel faults. The funnel was connected to horizontal fractures in the chalk that eventually developed into an open channel where river sediments were deposited. A minor surface stream that eroded the upper part of the doline achieved the further development. It produced the plug of fallen chalk fragments in the fun-

nel shaft and triggered the sliding down of a block of solid chalk (Fig. 12). A fining-upwards succession of bedded fine sand and silt eventually filled the channel.

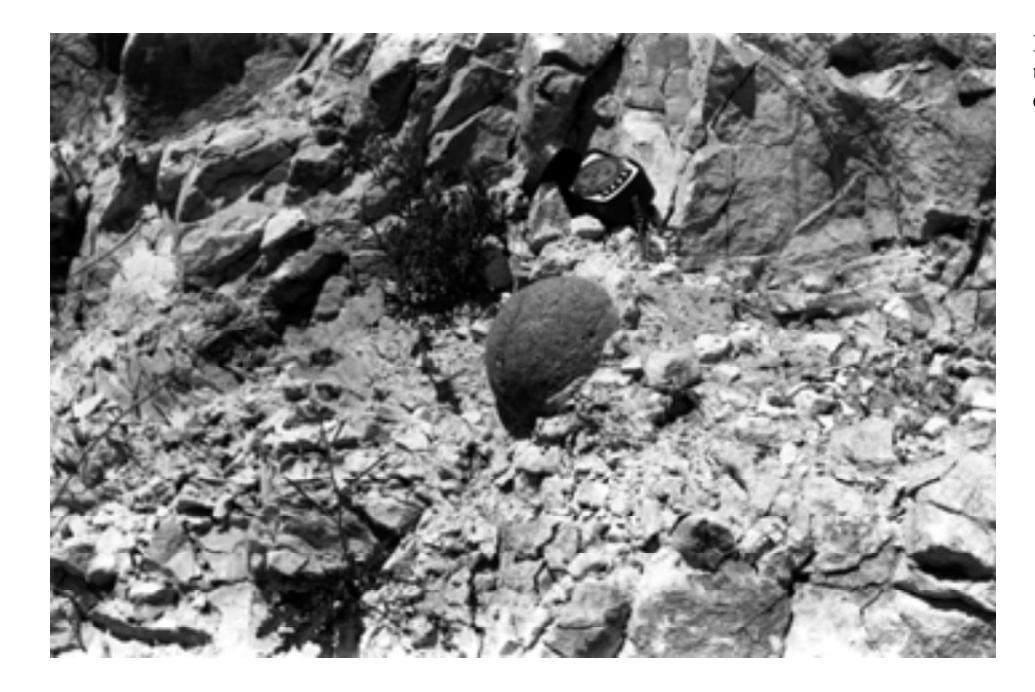
Fig. 13. Locality 4. Channel in the chalk filled with sand and cobbles. Cfr. fig. 12, item (10).

in the bottom of the funnel shaft and in the channel (Fig. 13). The funnel was filled with fallen chalk fragments covered by stratified fine-grained sand and silty fine sand.

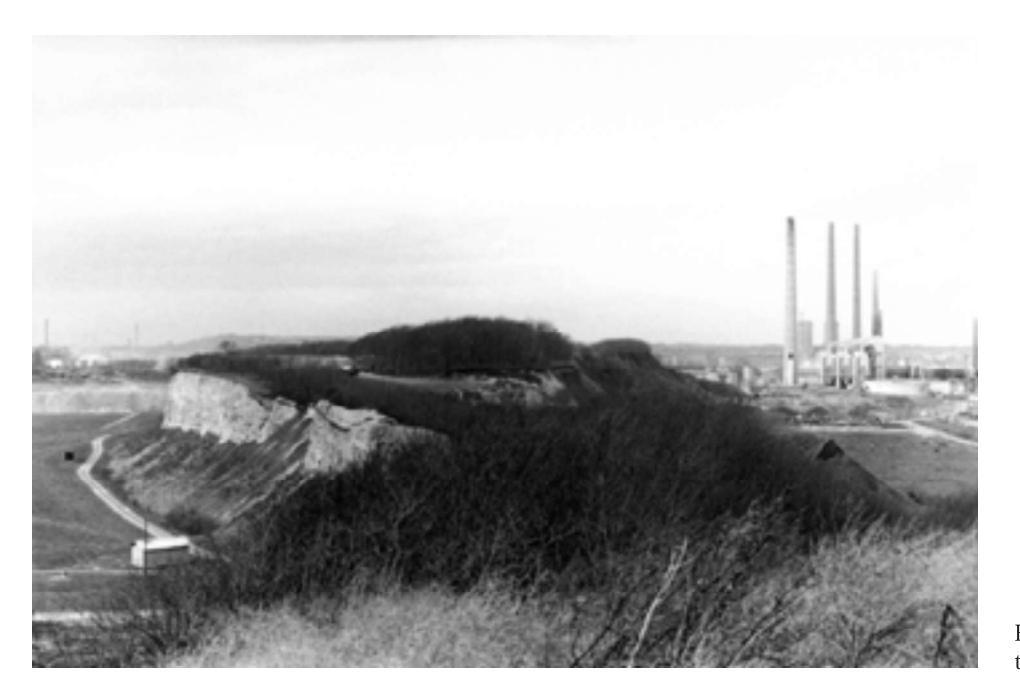
Fig. 14. Dybdal. Viewed from the East.

The c. 100 m wide Dybdal valley was left behind during quarrying as a 10–20 m high 'wall' between the quarried areas (Fig. 14). The profile (locality 5, Fig. 15) represents the south side of the valley. The side of the valley is here a steep or overhanging wall of chalk in contact with fine-grained sand that is very well sorted, finely laminated or cross-bedded. The same type of contact is seen at the nearby locality 3 (Fig. 2) between graded silt without chalk and an overhanging chalk wall (Fig. 16). The chalk wall at locality 5 is oriented NE-SW, almost perpendicular to the main direction of the valley at this point but it coincides with the direction of the joints. In the valley Late Glacial fine-grained sand and silt is interbedded with coarse-grained sand, pebbly sand and sand with cobbles up to 20-30 cm diameter. Some of the drilled sections have indications of cyclic sedimentation that may reflect climatically controlled changes in the Late Glacial flow of melt water (Fig. 17). The fining-upward cycles have coarse pebbly sand at the base overlain by progressively finergrained, well-sorted sands. The content of chalk mud and silt is low at the base of each cycle and increases

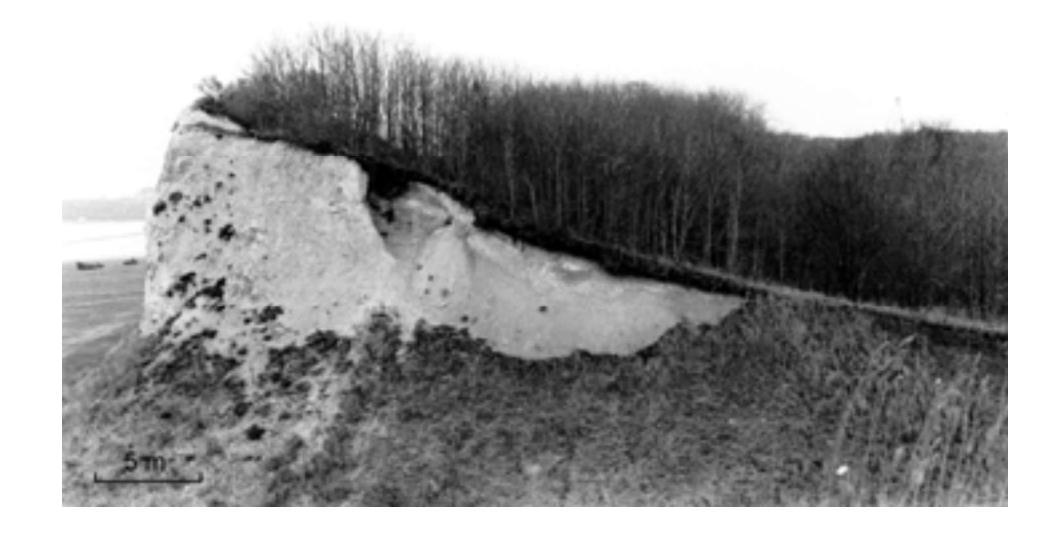
Fig. 15. Locality 5. Section of the south side of the Dybdal valley.

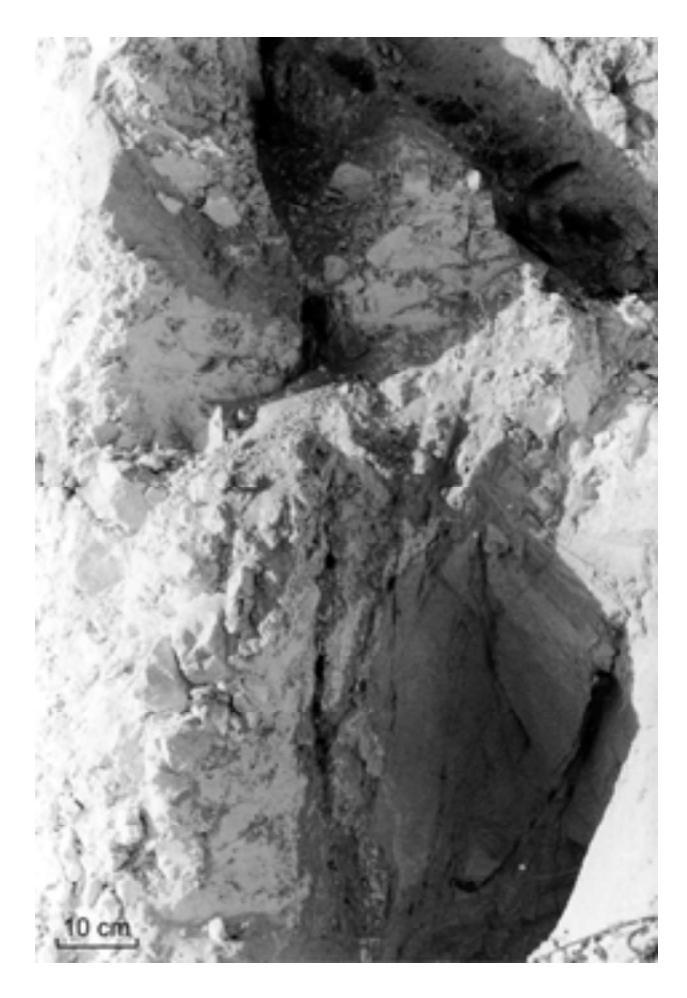
Fig. 16. Locality 3. Contact between the chalk wall and the valley-fill sediments of Dybdal.

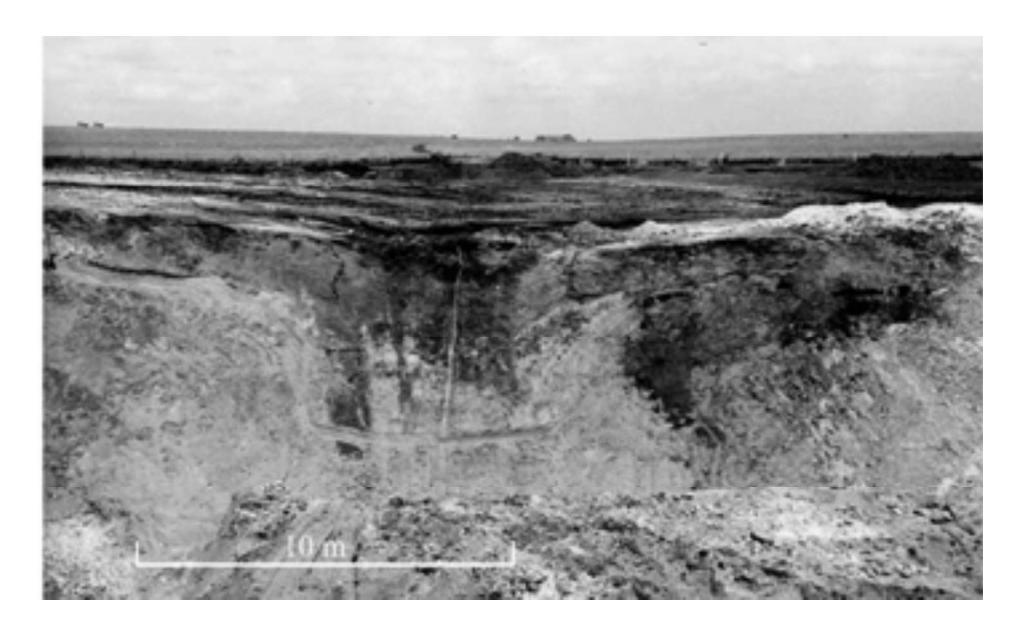
Fig. 18. Locality 2. The excavated cross-section of the uppermost part of the Øster Sundby valley viewed from the south. The buried valley is hardly visible in the terrain. The 10 m bar refers to the section in the centre of the picture. Barely visible spades right and left in the picture and a ranging pole in the centre for verification of the scale.

joints and faults in the chalk just like the Dybdal valley. A cross section (Fig. 18) was excavated in one of the deeper parts of the valley (Fig. 2, locality no. 2). This section did not reach the bottom of the valley and so a borehole was made at the profile (Fig. 2, borehole 1973/1). The composite profile is based on data from the excavation and the borehole (Fig. 19). The cross section of the excavated part of the valley is almost funnel-shaped. The section is c. 25 m wide at the top and c. 15 m wide at the bottom of the excavation at level +14 m. The upper 5 m of the western chalk wall of the valley is almost vertical. Below this level the wall dips towards the axis of the valley. The eastern chalk wall is overhanging to vertical. The chalk is somewhat disintegrated and clayey at the contact to the sandy valley fill, and this together with the steep and overhanging walls and the irregular funnel shaped cross-section seem to indicate that karstic processes have been active. The chalk-walls of the upper part of the valley are covered by 0.5–1 m silty and clayey sand sediment with abundant chalk clasts (Fig. 19, bed G). The sediment shows some similarity to boulder-clay (till) but it is slightly stratified and is supposed to have flowed into the valley as a debris flow.

The bedding and sedimentary structures across the profile indicate that the valley sediments subsided at a late stage of Quaternary sedimentation (Fig. 18). The bed named A in figure 19 was followed across the profile. It was evenly bedded in the middle of the valley. Near the sides of the valley, however, it was broken up into short subvertical flakes that could be followed c. 4 m upwards to a level, where the bed was again almost horizontal but was dissected by antithetic micro-faults. The subsidence of the central sediment package could be traced into the lower part of the sediment package above bed A, but it could not be established whether the subsidence was diminishing upwards which would indicate that the subsidence took place over a period of some length, possibly to the end of the sedimentation.

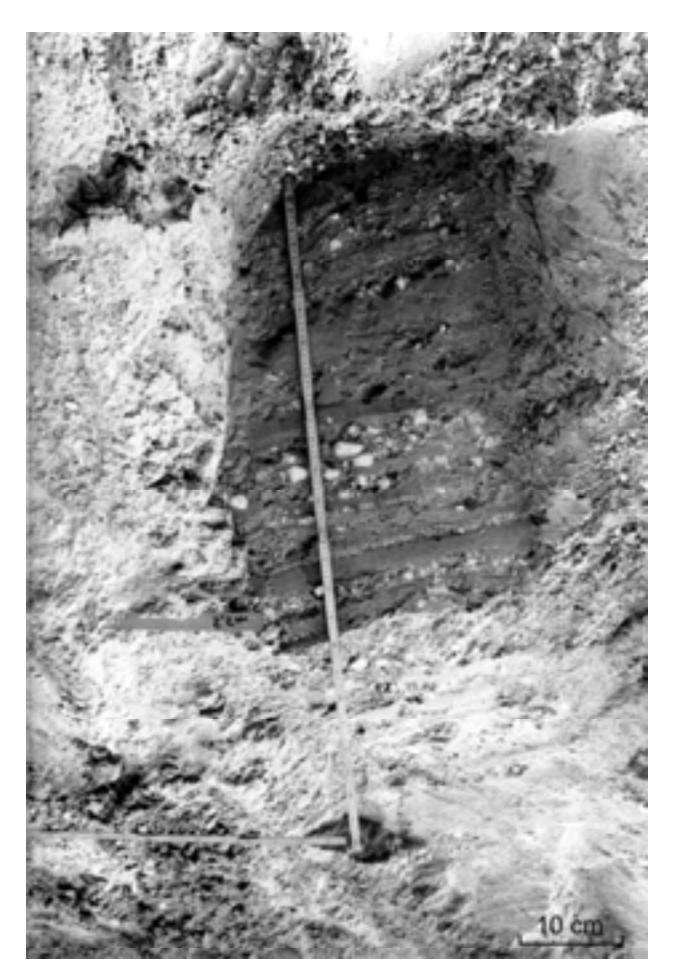
Fig. 20. Locality 2. Stratified contact sediments c. 5,5 - 6,3 m below the top of the excavated cross-section (Figs 18, 19).

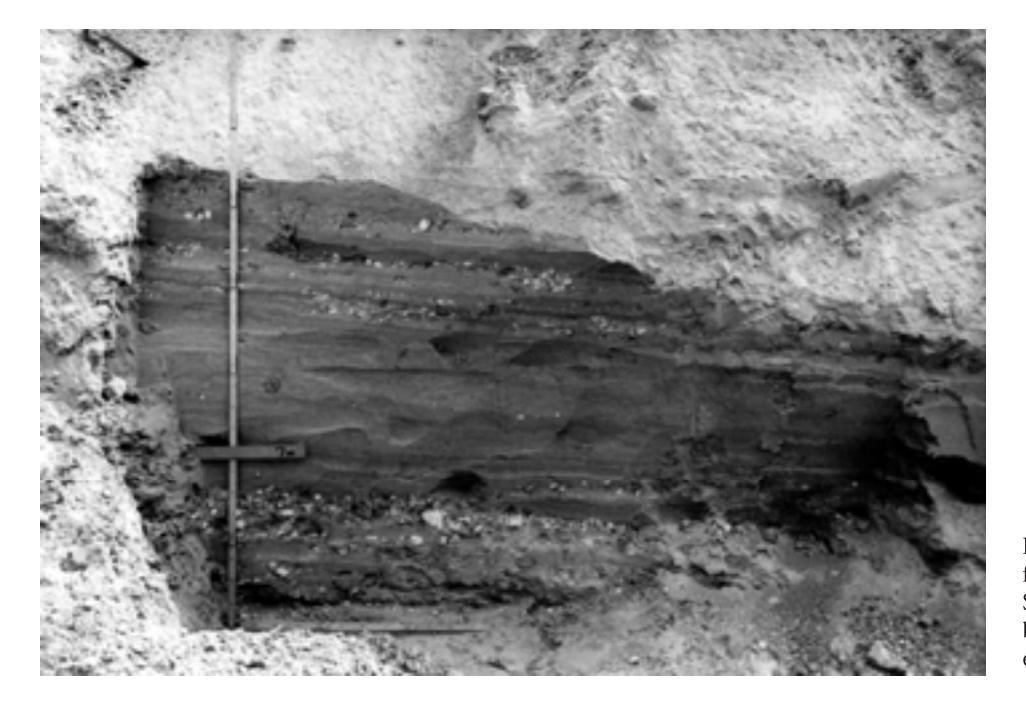
Fig. 21. Locality 2. Sediments from the axis of the Øster Sundby valley c. 6,3 – 7,4 m below the top of the excavated cross-section (Figs 18, 19).

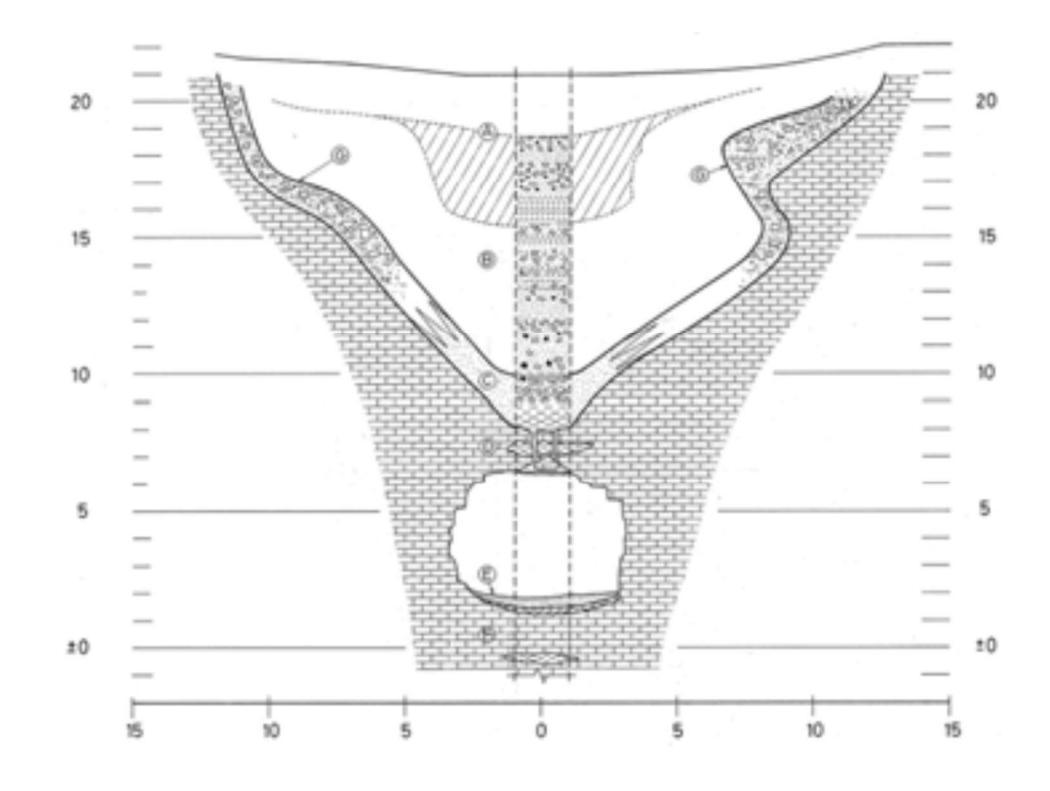
Fig. 22. Locality 2. Tentative section of the Øster Sundby valley before collapse of an assumed cavity. Key as in Fig.17.

Possible explanations of the subsidence might include 1) compaction of underlying soft sediments such as peat or clay rich in organic matter, 2) melting of remains of glacier ice in the deeper parts of the valley, or 3) collapse of a cavity in the chalk. Options 1) and 2) are not supported by sedimentary evidence as there was no trace of organic sediments or genuine till deposits. This leaves option 3) as the most likely explanation. For instance, the bed marked D in figure 19 may represent the roof of a collapsed cave. A tentative profile of the valley before the collapse of an assumed cavity is shown in figure 22.

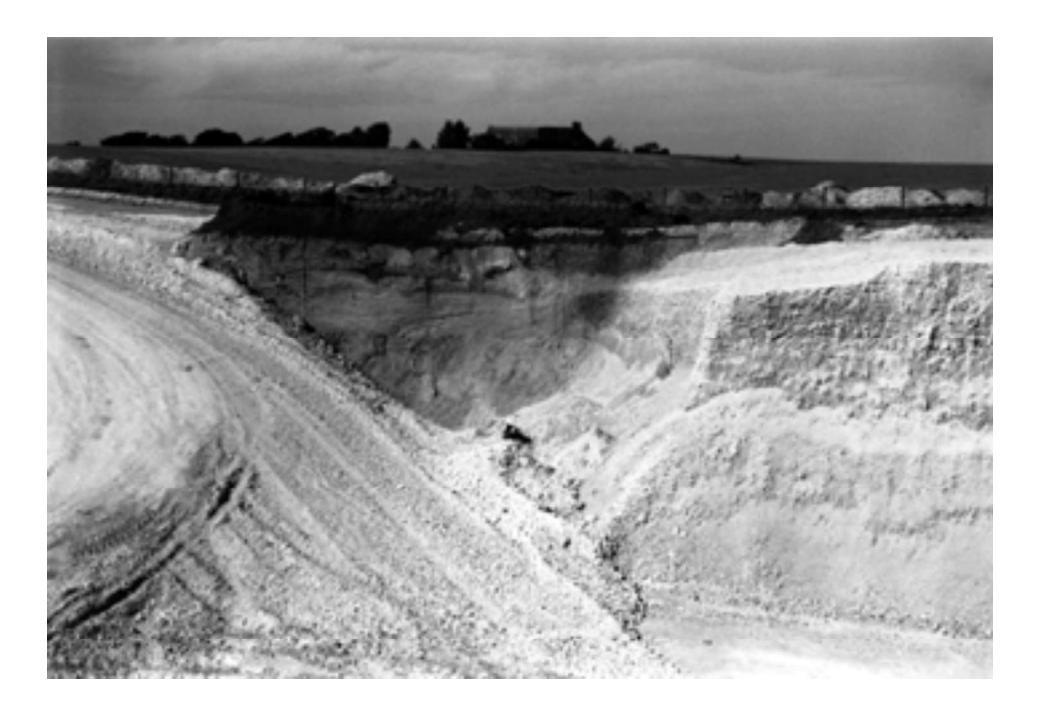
Fig. 23. Locality 6. Øster Sundby valley cross-section. Note spade for scale.

At locality 6 the chalk wall of the valley was vertical or slightly overhanging (Fig. 23). The valley fill

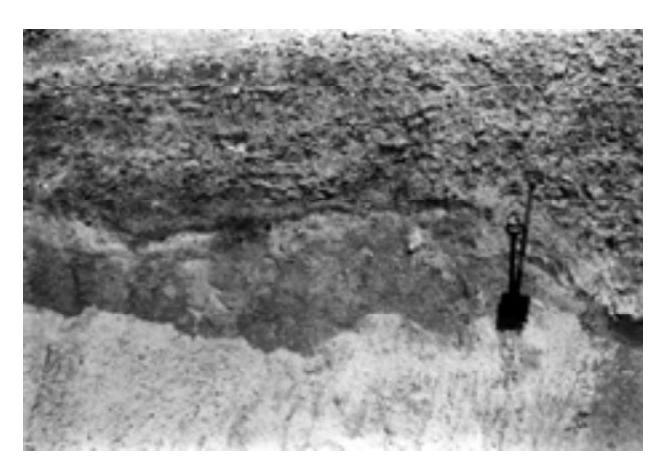
Fig. 24. Locality 6. Close up of the sidewall of the easternmost branch of the Øster Sundby valley. The chalk (at top of the photograph) is covered by greyish brown slightly argillaceous pebbly sand, and towards the axis of the valley by sands with chalk fragments (bottom of photograph). In the axis of the valley are alternating beds of fine sand and chalk fragments.

comprises greyish brown slightly argillaceous pebbly sand (Fig. 24). Towards the axis of the valley sand with chalk fragments occurs and in the axis alternating beds of fine sand and chalk fragments having much the same appearance as the sand at locality 2.

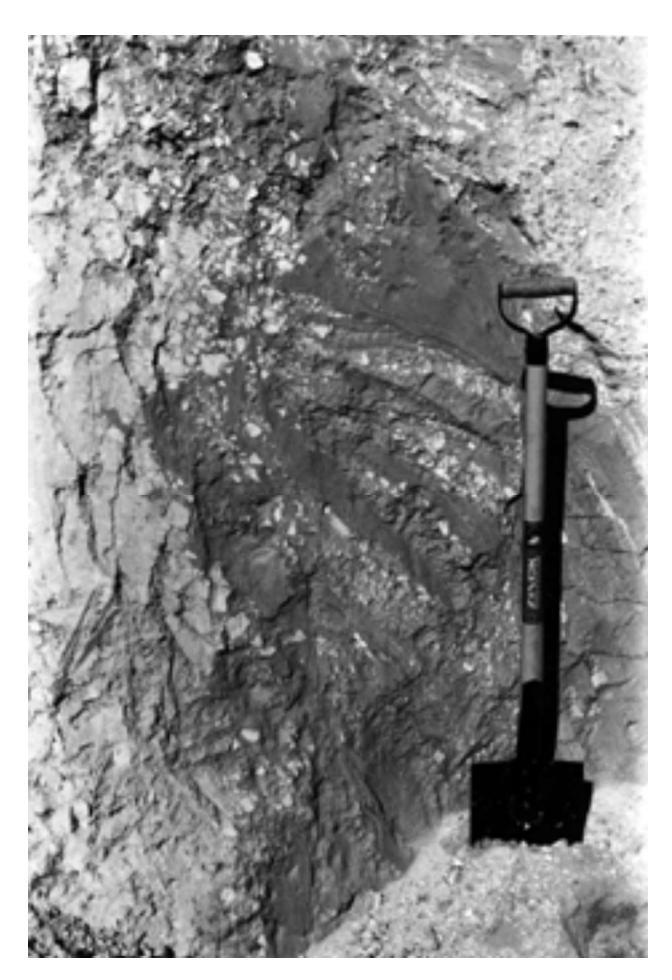
Fig. 25. Locality 7. Close-up photograph of valley-fill sediment and contact to the chalk wall in the westernmost branch of the Øster Sundby valley (Figs 2, 4).

were laid down by series of small debris flows (Fig. 25). Angular chalk fragments that are imbedded in the sand outline the structural details and the assumed development of the sediment package. The succession seems to have been deposited in an open valley incised into the chalk. Clayey and silty sand was deposited in the valley by debris flows alternating with beds formed by fall of chalk pebbles from the fractured walls. Also at this locality a subsidence of the sediments in the valley has occurred. This happened mainly but not exclusively by small scale faulting c. 0.5 m from the chalk wall (Figs 26, 27). The distribution of the chalk fragments indicates drag, draw-out and vertical displacement of the beds along the faults. In the axis of the valley Late Glacial streams deposited horizontally bedded sand with chalk pebbles (Fig. 28). The data from locality 6 and 7 on the uppermost part of the valley support the observations from locality 2, including the subsidence of Late Glacial sediments, but they yield no details of the subsurface drainage system.

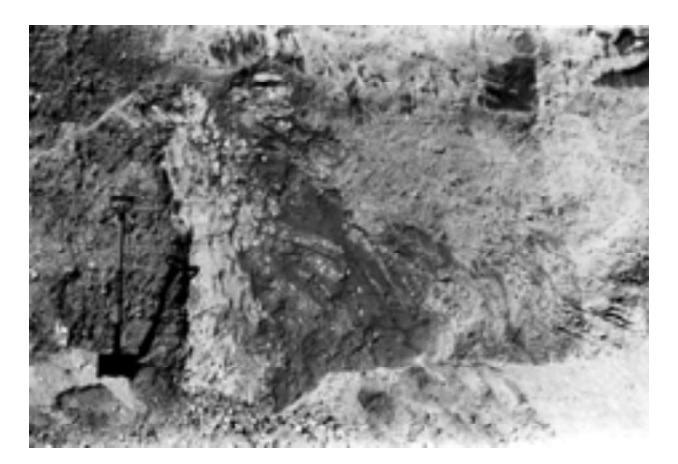
Fig. 26. Locality 7. Photograph of section in the westernmost branch of the Øster Sundby valley showing minor faults and subsidence structures.

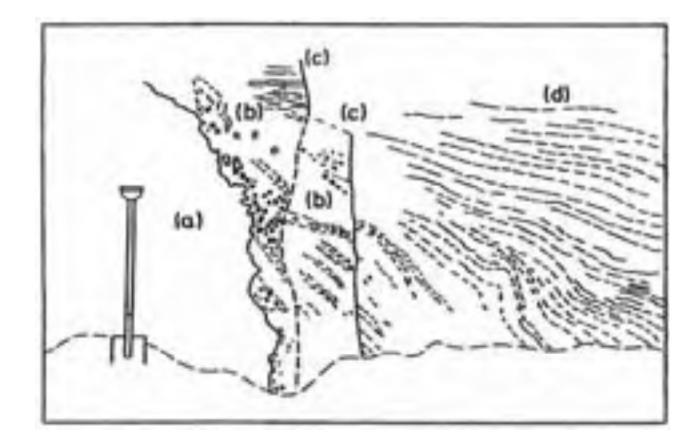
Fig. 27. Locality 7. Explanatory sketch to the photograph figure 26. (a) Chalk; (b) Stratified sand and silt with chalk fragments – possibly a debris flow deposit; (c) Faults; (d) Stratified sand and gravel. Note the subsidence structures.

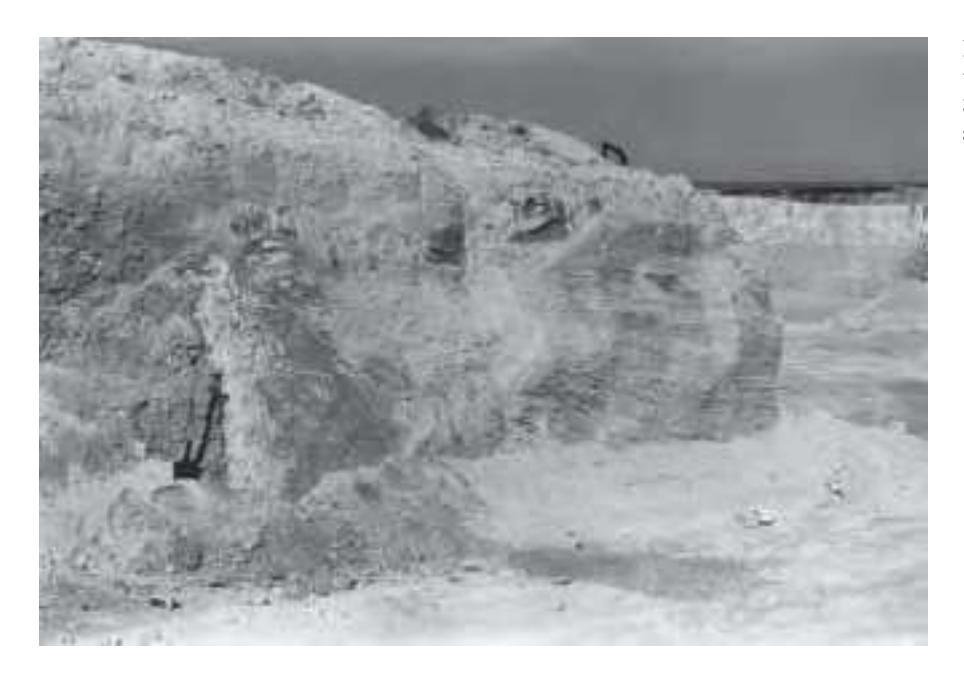
Fig. 28. Locality 7. Photograph of the westernmost branch of Øster Sundby valley showing sediment structures across the section.
